STS-106/2A.2b Flight Readiness Review

August 29, 2000

Johnson Space Center

EMU Oxygen Contamination

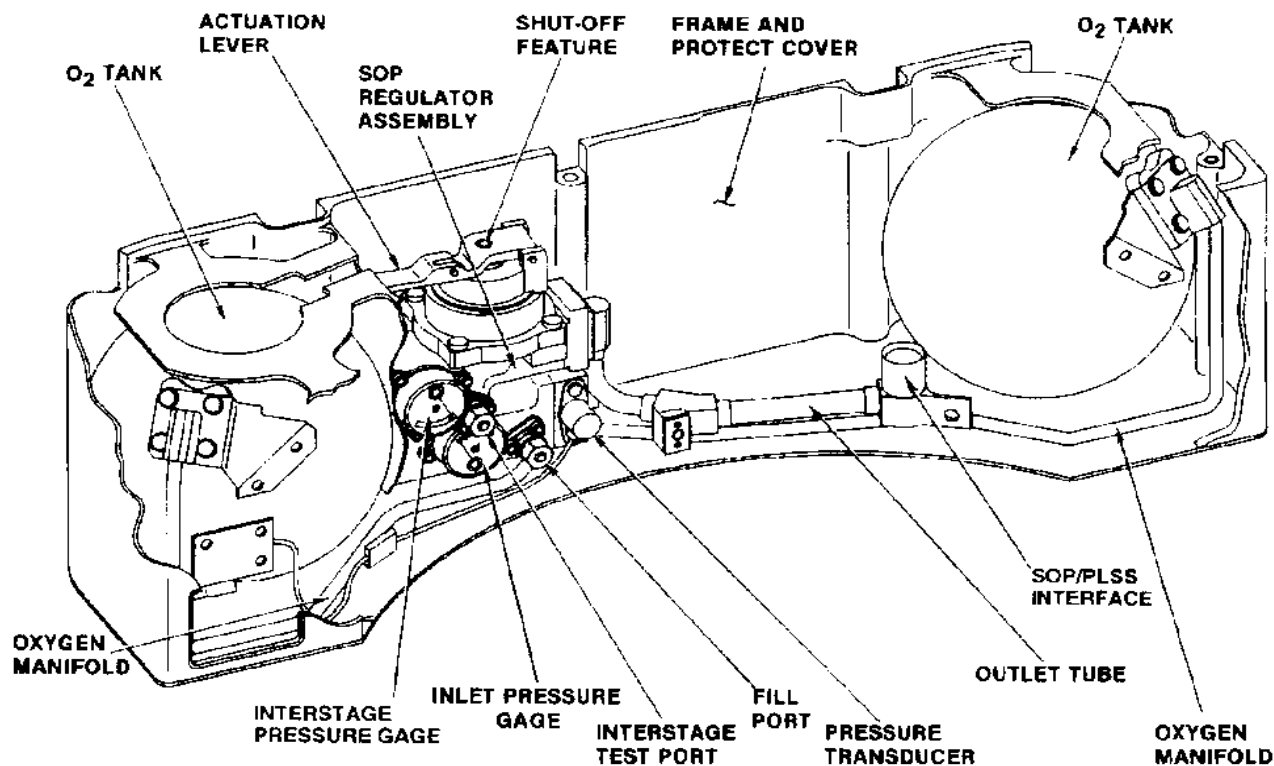
SECONDARY OXYGEN PACK (SOP)

- During investigation at the vendor (Carlton Technologies) for an internal leakage of Secondary Oxygen Pack (SOP) S/N 119 regulator, liquid droplets of contamination were noted
- The contamination was determined to be a mix of fluorocarbons, hydrocarbons, and silicone oils. Subsequent inspection of other SOP regulators revealed contamination in all SOP regulators (range of contaminants was 3.3 to 233.3 mg/ft²)

- Upon discovering contaminants in SOP Regulator S/N 119, all SOP's were considered suspect and returned to the vendors for investigation
 - 12 SOP regulators were inspected and all were contaminated
 - 9 sets (2/set) of SOP bottles and 7 SOP manifolds were also inspected and found to be clean

- **Root Cause**
 - No single identifiable root cause has been determined
 - Cumulative effect of contaminants condensing in regulator is most probable cause
 - Analysis confirms allowable hydrocarbon levels in O₂ supply could condense in SOP regulator
 - Contamination isolated to SOP regulator
